**SAS Superstructure**

Location: 04-SF-80-13.2 / 13.9

**Daily Diary Report by Bid Item**

Diary #: 774 Const Calendar Day: 241 Date: 31-Jan-2013 Thursday

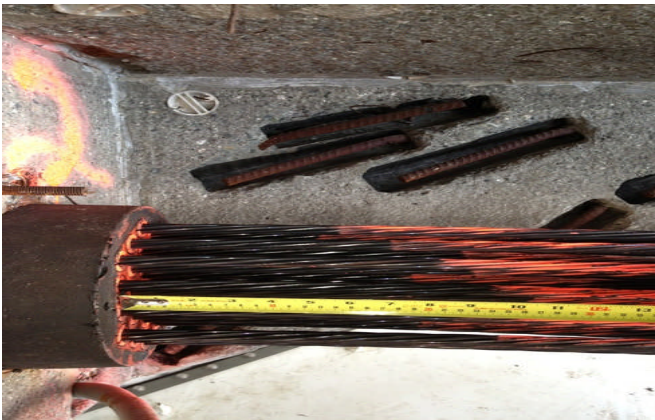
Unequal elongations measured after using the monostrand ram on CBT-7, where the stressing of this tendon is rejected.

Similarly the monstrand ram 6-8-138 (gauge A) was used in an attempt to stress transverse tendon CBT-7 from the south end of the W2 cap beam. Each of the 27 strands in this tendon were stressed up to 20%, 60%, then to 100% working in a circular pattern starting from the outer strands working towards the center strand. The elongations for the 27 strands varied from 4" to 10" which was unacceptable, see photo below for more details. I informed SDI personnel as well as ABF engineers Levi Gatsos and Mark McDonald that the tendon must be detensioned and restressed with the 600 ton ram since the elongations were out of tolerance (+/- 7%) and unbalanced.

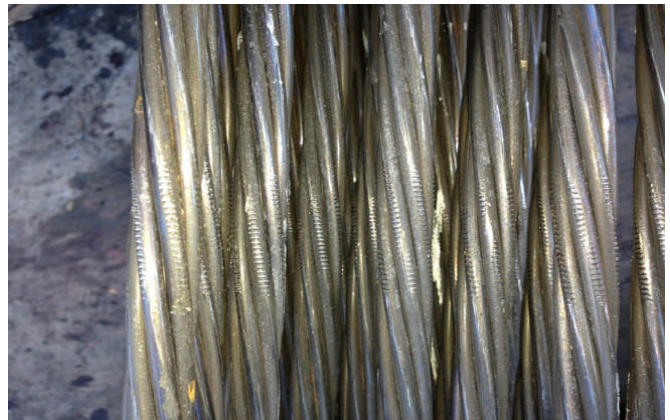
Uniform wedge marks seen on the strands of CBT2 after single end stressing with the 600 ton ram from the North end of the W2 cap beam.

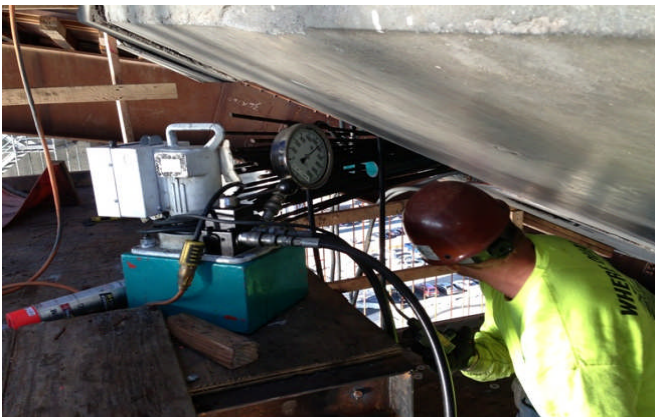
SDI ironworker using the monostrand ram to stress CBT-7.
